Adams Pond and Knickerbocker Lake Watershed Survey

**BOOTHBAY REGION
WATER DISTRICT**

September 2014

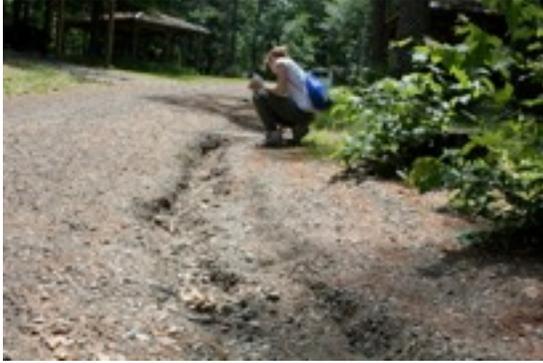
Erosion of this private road on Knickerbocker Lake has resulted in sediments and phosphorus entering the lake.

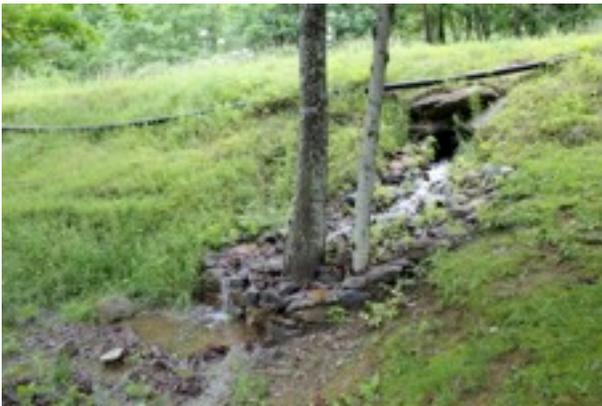
This unstable, poorly designed and maintained culvert has caused significant erosion of a residential property on Knickerbocker Lake. Culvert replacement with proper design to slow and intercept flows is needed.

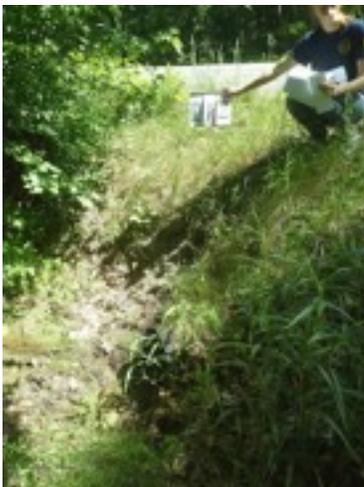
When plunge pools become filled with sediment they are incapable of trapping more.

Routine maintenance can ensure plunge pools continue to capture sediments.

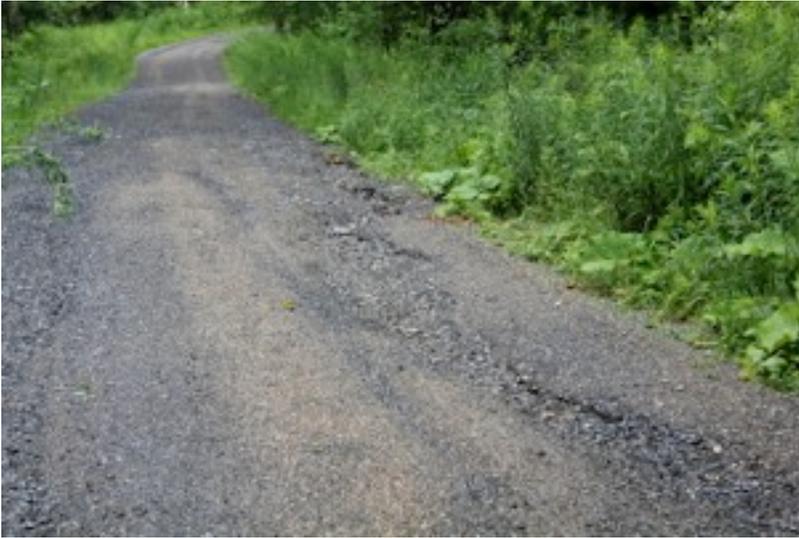
Steep gravel roadways are susceptible to road surface erosion.

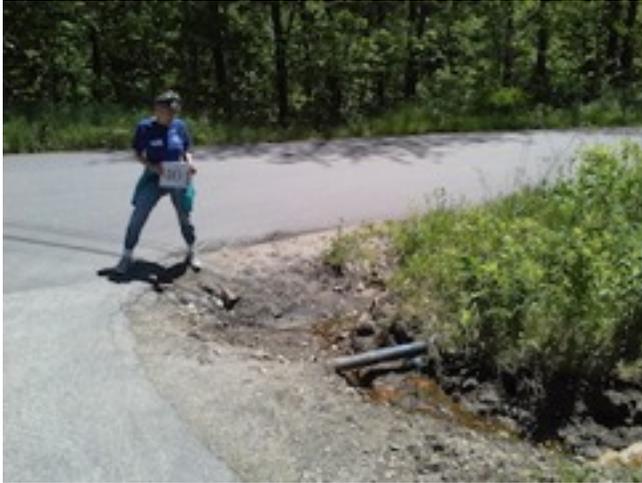
Erosion around culverts and roadway ditches was seen at several road sites during the survey.

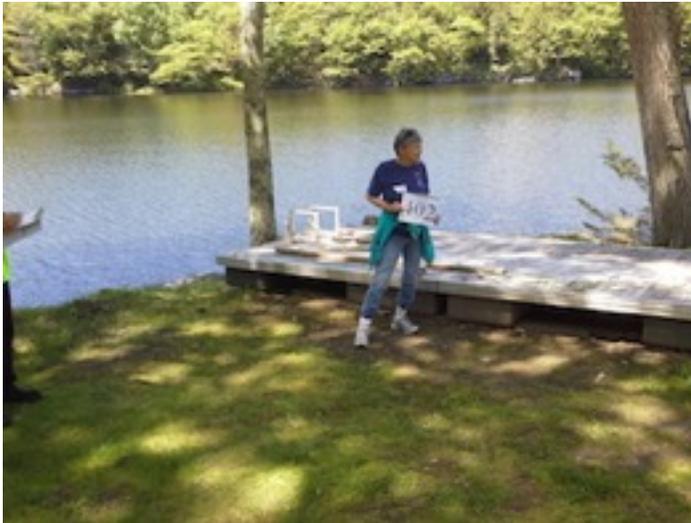
Surface erosion and bare soils on shoreline properties contribute runoff to lake. Mulching or vegetating problem areas and creating defined foot paths can help solve these problem areas.

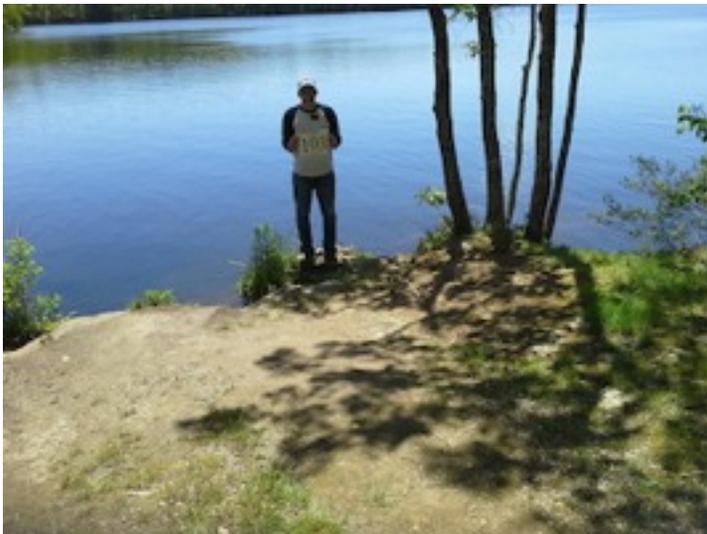
Undefined foot paths can lead to bare soil and erosion.

Creating a defined trail and revegetating areas could resolve erosion at this and other access points on Adams Pond.

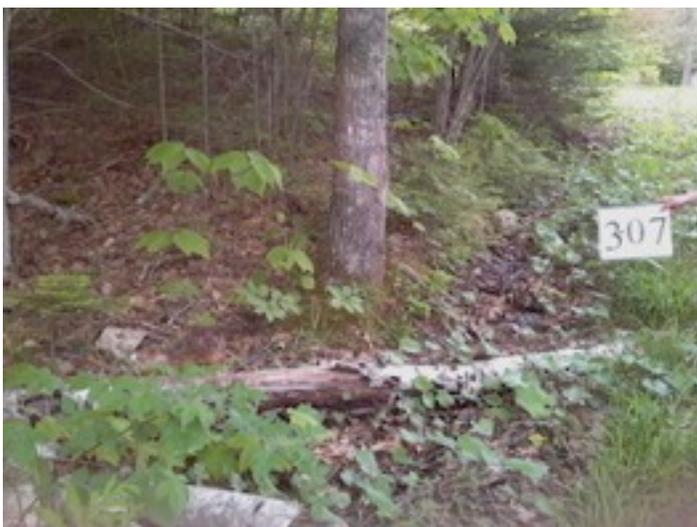
An eroded gully along this shore access point could be addressed by placing check dams and armoring the ditch with stone.

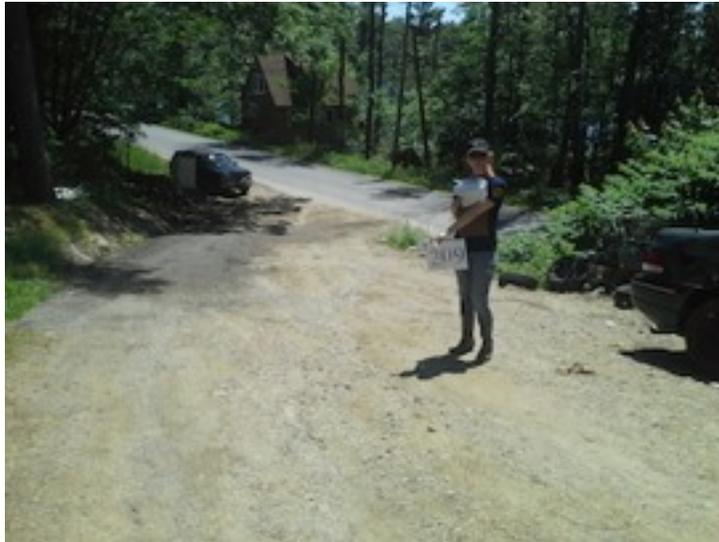
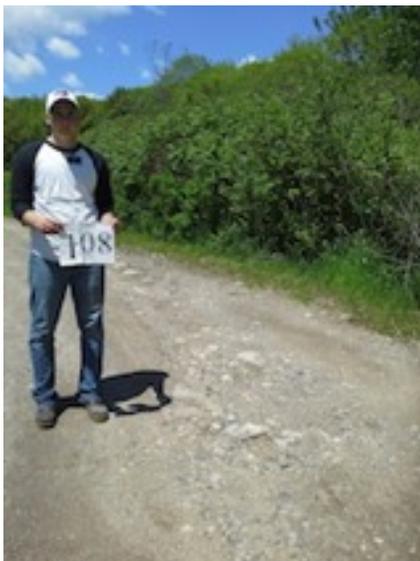
Severe surface erosion was observed on steep driveways in both watersheds.

Resurfacing and installing runoff diverters and turnouts can reduce erosion problems and keep gravel on driveways and out of the lake.

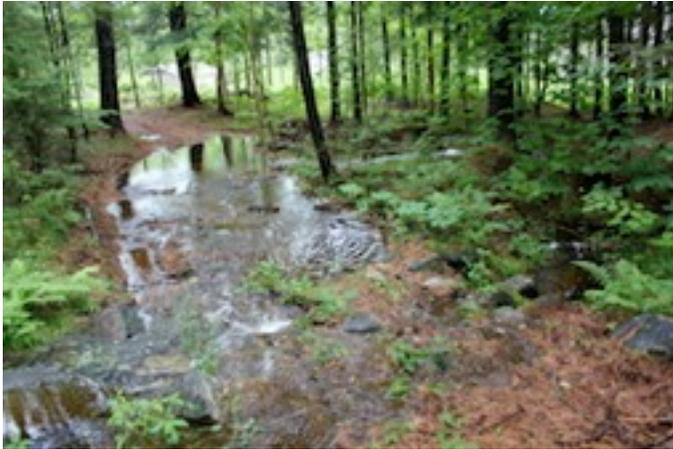
A crushed culvert at this stream crossing means a flooded trail and eroded sediment entering a stream that flows into Knickerbocker Lake.

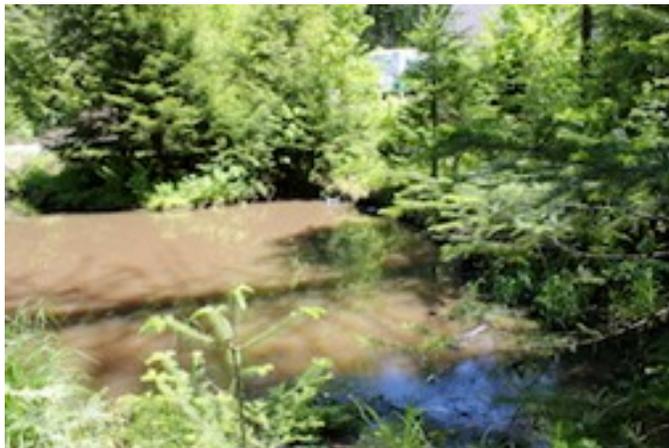
Landscaping at this residential site without the use of best management practices resulted in sedimentation into this ponded stream and downstream to Knickerbocker Lake.
