# Plugging the Holes

Addressing Non-Point Source Pollution  
in  
Adams Pond and Knickerbocker Lake watersheds  
2015-2017

Susan Mello  
Boothbay Region Water District  
184 Adams Pond Road  
Boothbay, Maine  
April 2018

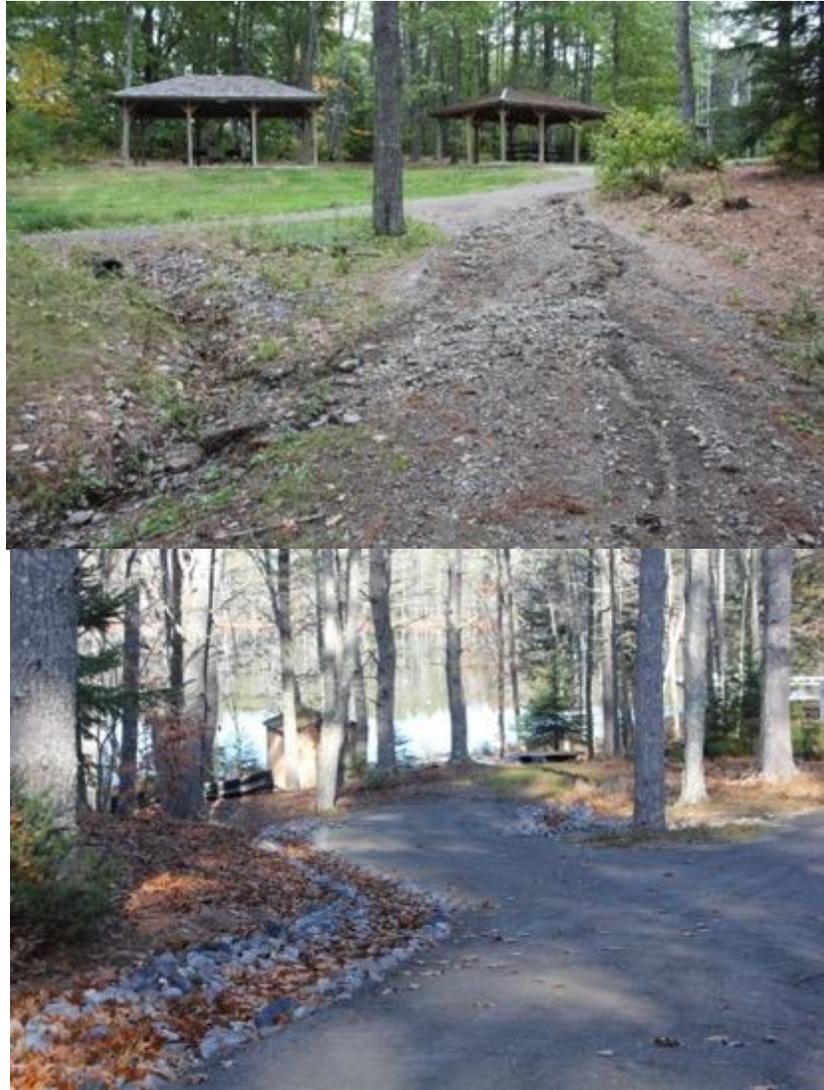
Figure 1. Before and after photos of camp road.

To alleviate runoff and erosion problems, the entire gravel access road at the lake front was resurfaced with ledgepack and properly crowned so runoff disperses off the roadway, and runoff diverters were installed. A roadside ditch was lined with rock and a plunge pool was installed near the shore to intercept runoff and sediments. Erosion around shelters was stabilized with ledgepack, as well. Access to the eroded shoreside trail was rerouted to a new trail farther away from the waterfront and properly mulched. The unstable access road to the swimming area was stabilized

with vegetated terraces and about 60' of Geoweb filled with rock and mulch. Mulch was applied to bare soils. Future plans include a vegetated buffer and more native plantings.

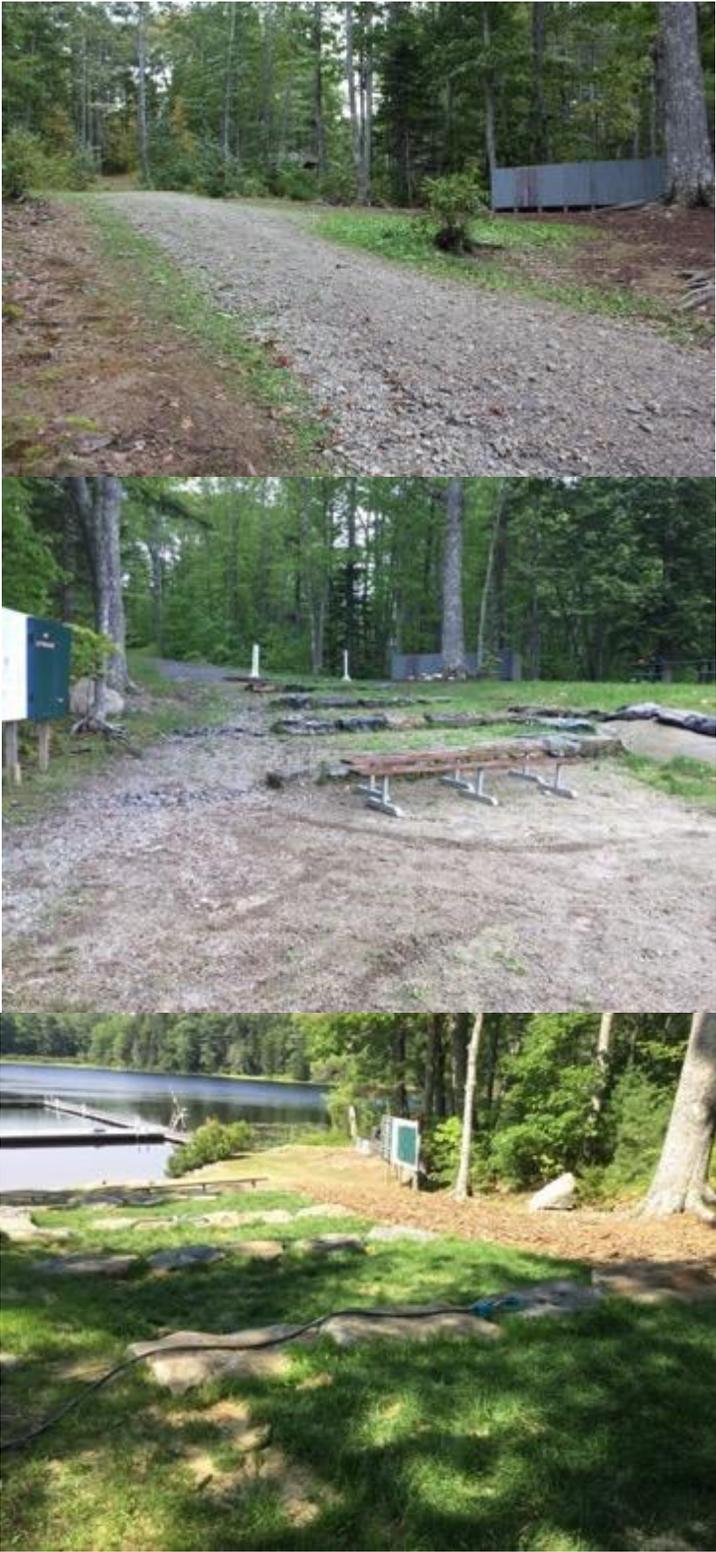
Figure 2. Beach access road in 2015, 2016 and 2017.

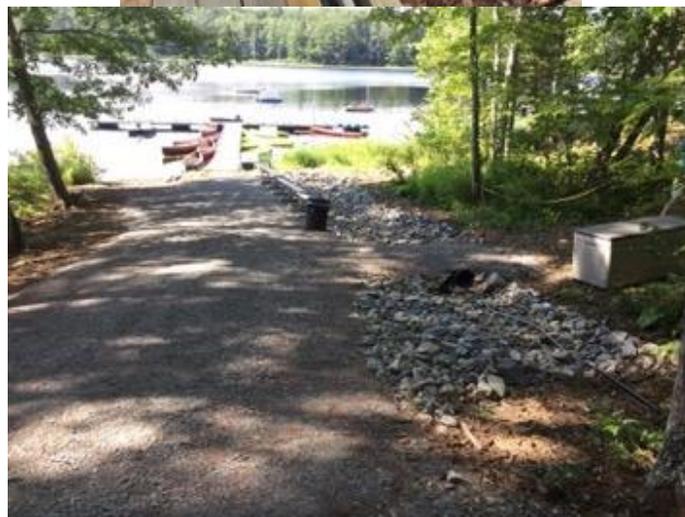
Figure 3. Boat access/storage site with bare soils and runoff in 2016. In 2017, road resurfaced; ditch/plunge pool installed and boats stored upland from shore.

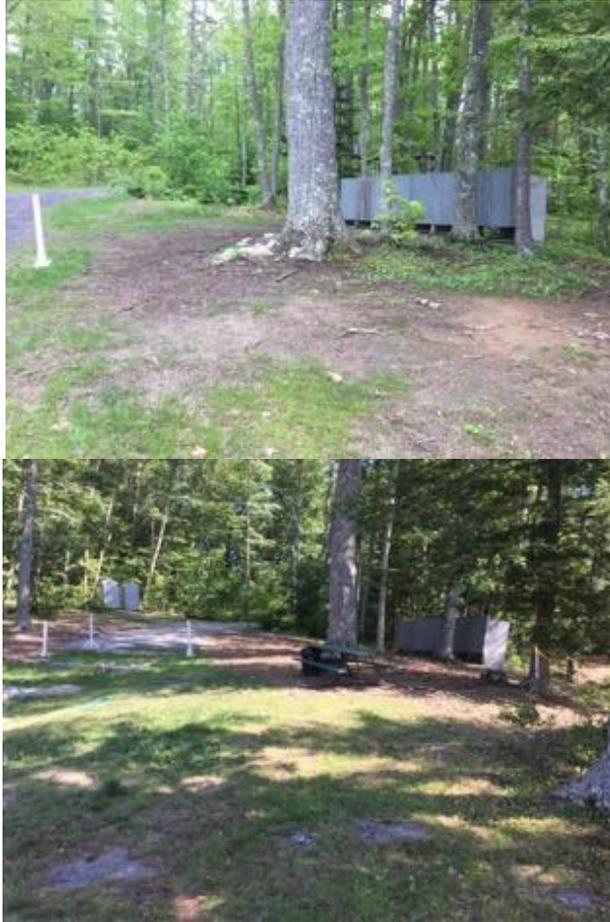
Figure 4. Bare soils around changing area 2016, mulched in 2017. Changing stalls will be removed and this area replanted in 2018-2019.

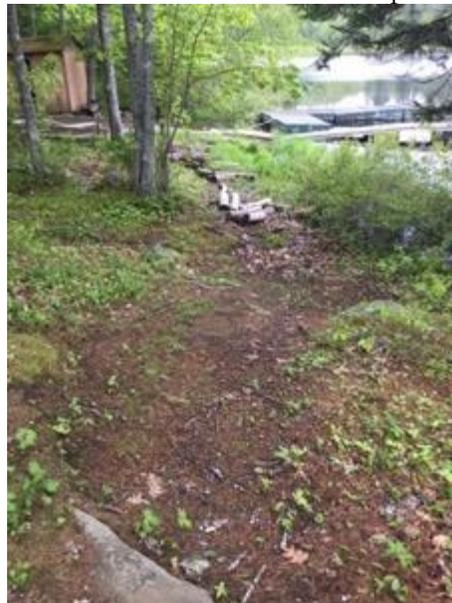
Figure 5. Shoreside trail through wetland discontinued. Will be planted in 2018.

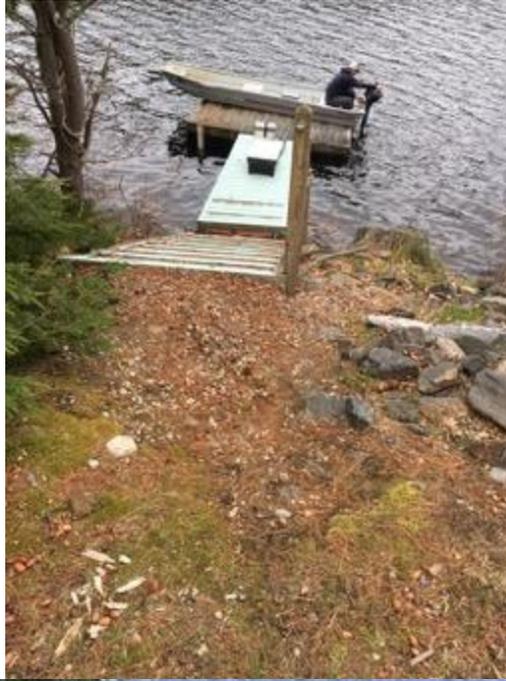
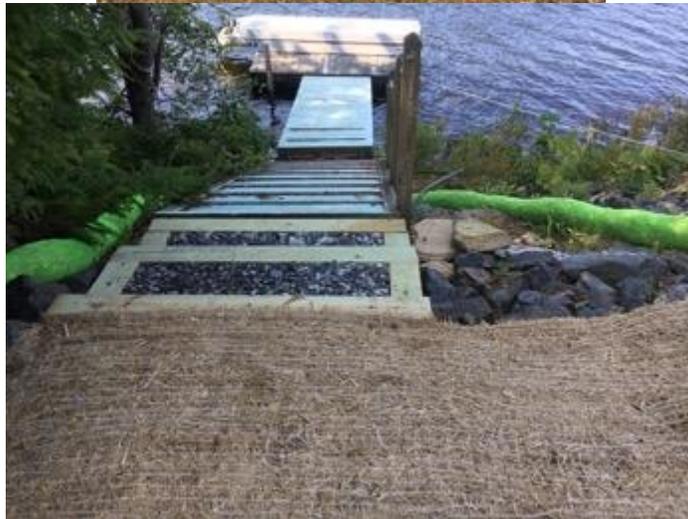
Figure 4. The dock access to Knickerbocker Lake at the BRWD water intake site was eroding with runoff to the lake. Infiltration steps were installed and the site stabilized with jute mat and seeded.

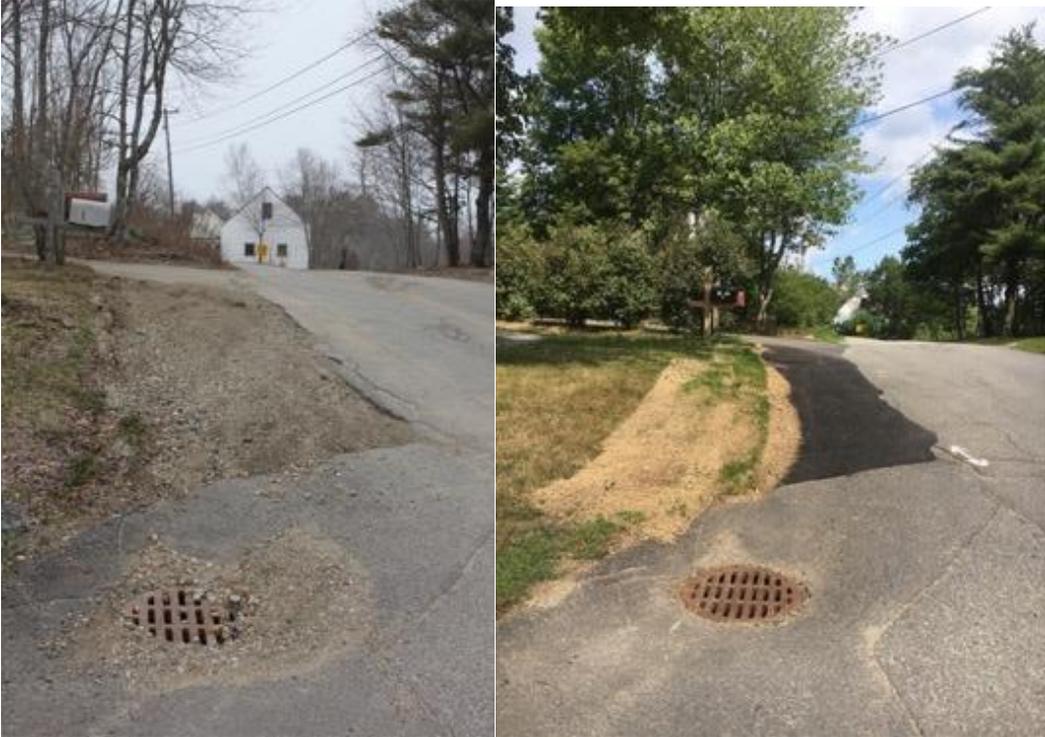
Figure 5. Eroded road shoulder at north end of road was paved and stabilized and seeded.

A steep, gravel road shoulder continually eroded and each year, gravel was replaced only to erode again. Road shoulders along about 500' of road were bare, with runoff entering a stream that crosses under Adams Pond Road. Remediation included paving the short stretch of steep, eroding road shoulder, stabilizing the rest of the road shoulder with jute mat and seeding, an unstable culvert embankment at the stream crossing was stabilized with riprap and a level spreader created to intercept runoff and reduce erosion. Work in 2018 will address parking lot runoff.

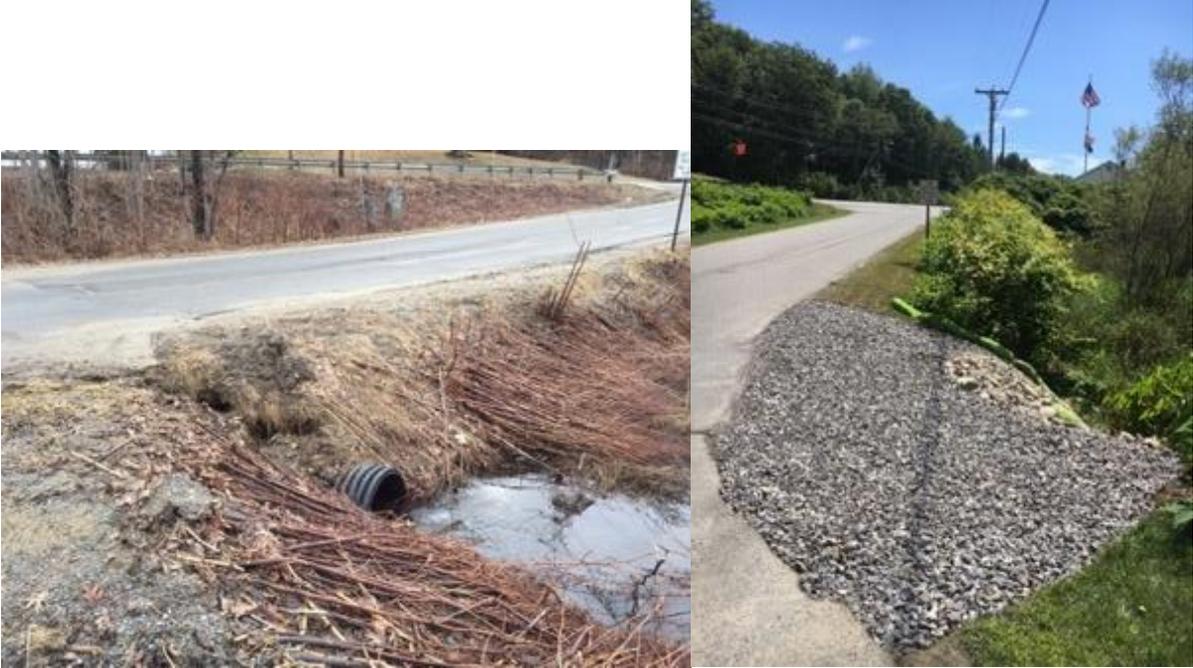
Figure 6. Unstable stream culvert at south end of site, before and after.

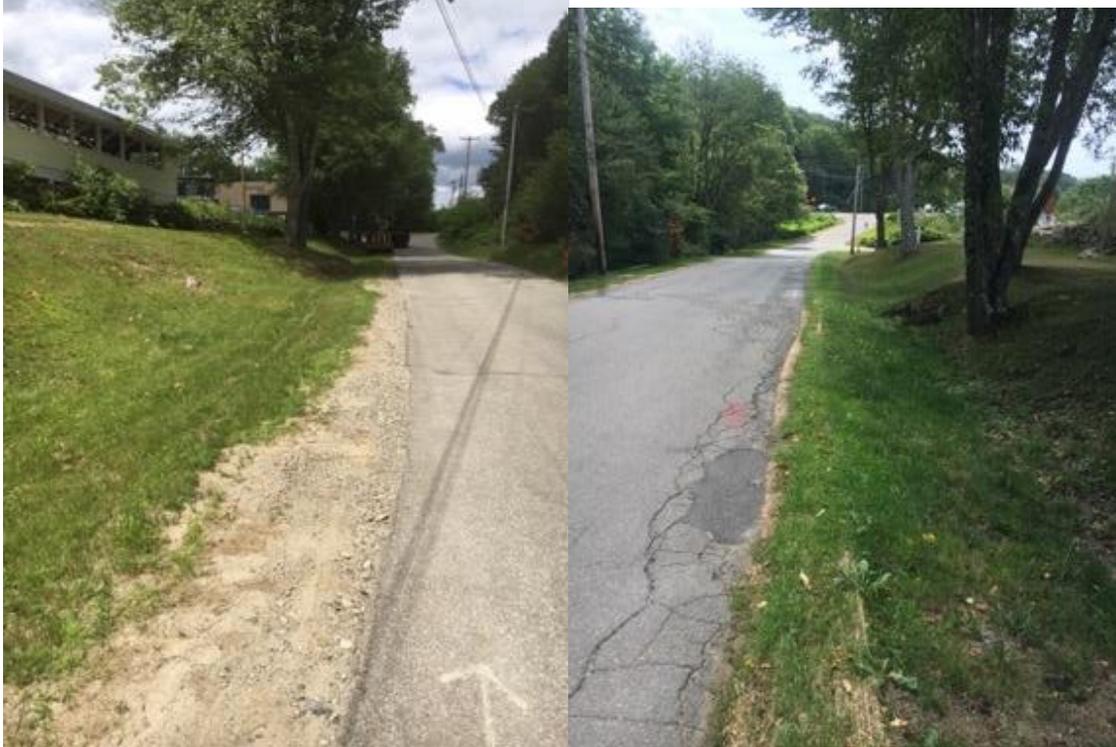
Figure 7. Road shoulder erosion, before and after stabilization and seeding.

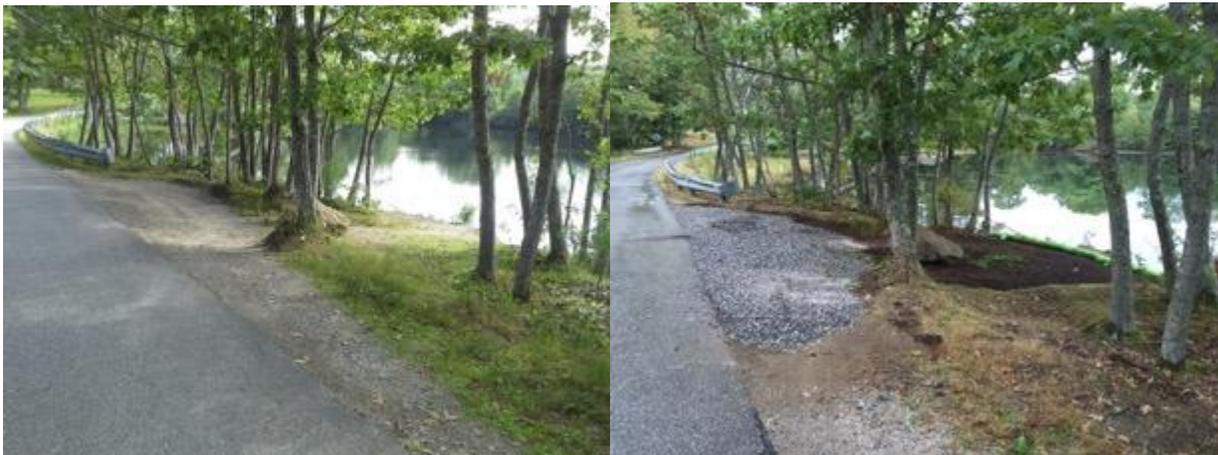
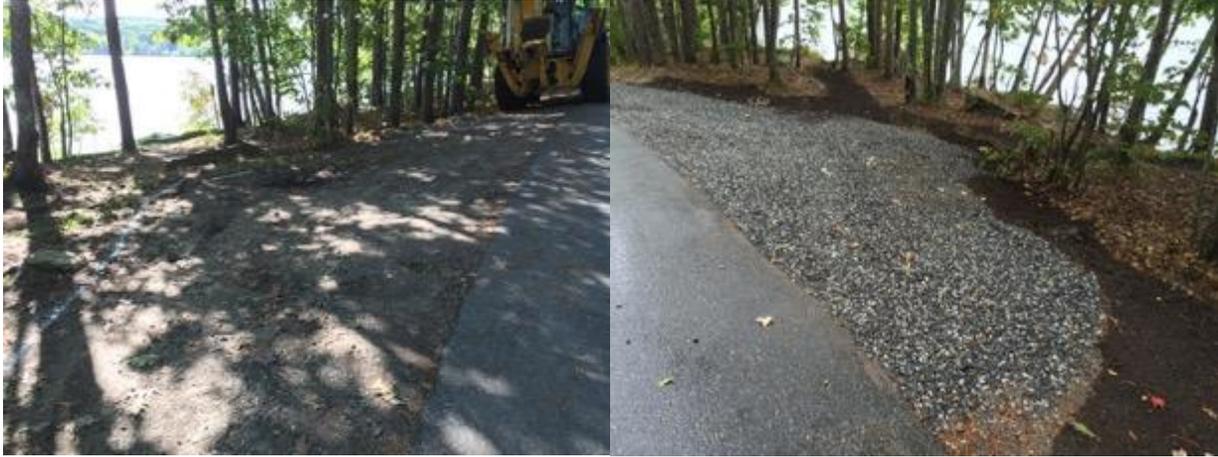
Figure 8. Lake access sites used for parking were eroding with bare soils and runoff to the lake. To remediate the sites, Geoweb was installed and filled with stone to create a stable, more permeable parking base. Paths were mulched with erosion control mix and bare soils planted. Additional planting will occur along Adams Pond Road in 2018.
